# THE PIZ CENGALO LANDSLIDE

TEAM: RINA KRAVCHENKO | PETRA ĐURIŠKOVÁ

LOCATION: VILLAGE OF BONDO, SWITZERLAND  
COORDINATES: 46.335318, 9.554227  
ALTITUDE: 823 M

# REDESIGN OF BONDASCA

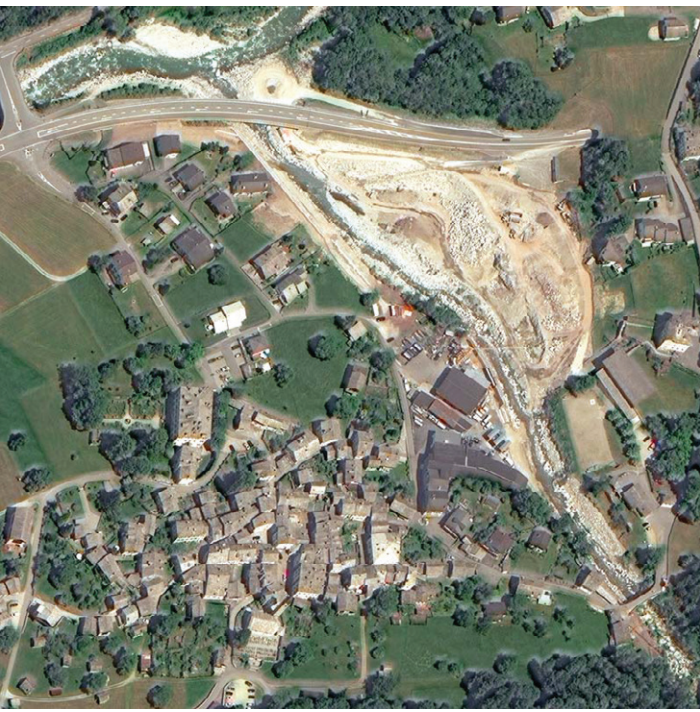
6 June 2015 . Bondo before the landslide. WorldView-3. EUSI

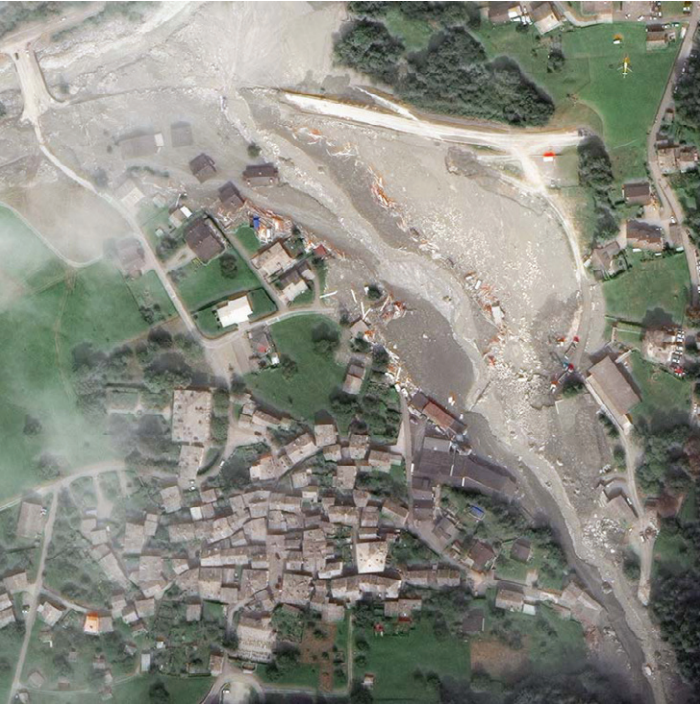
27 August 2017. Bondo after two landslides. WorldView-3. EUSI

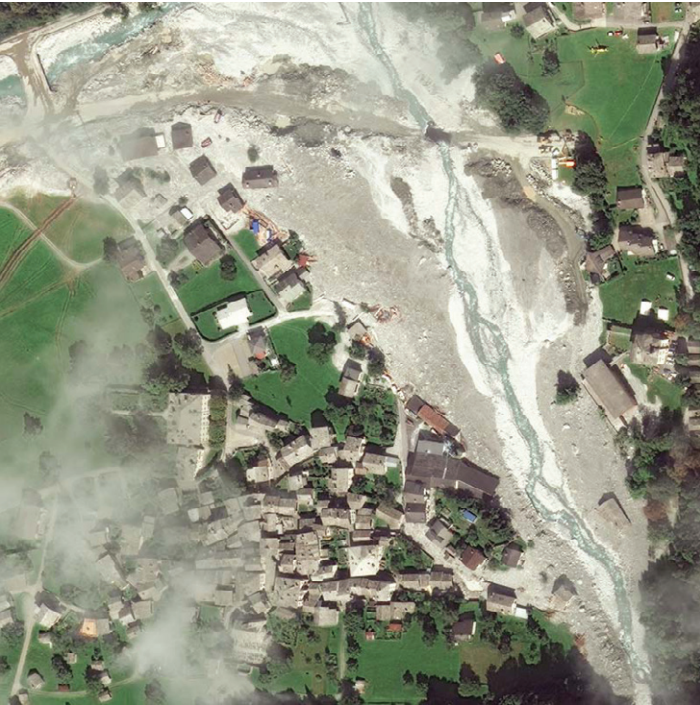
5 September 2017. Bondo after three landslides. WorldView-4. EUSI

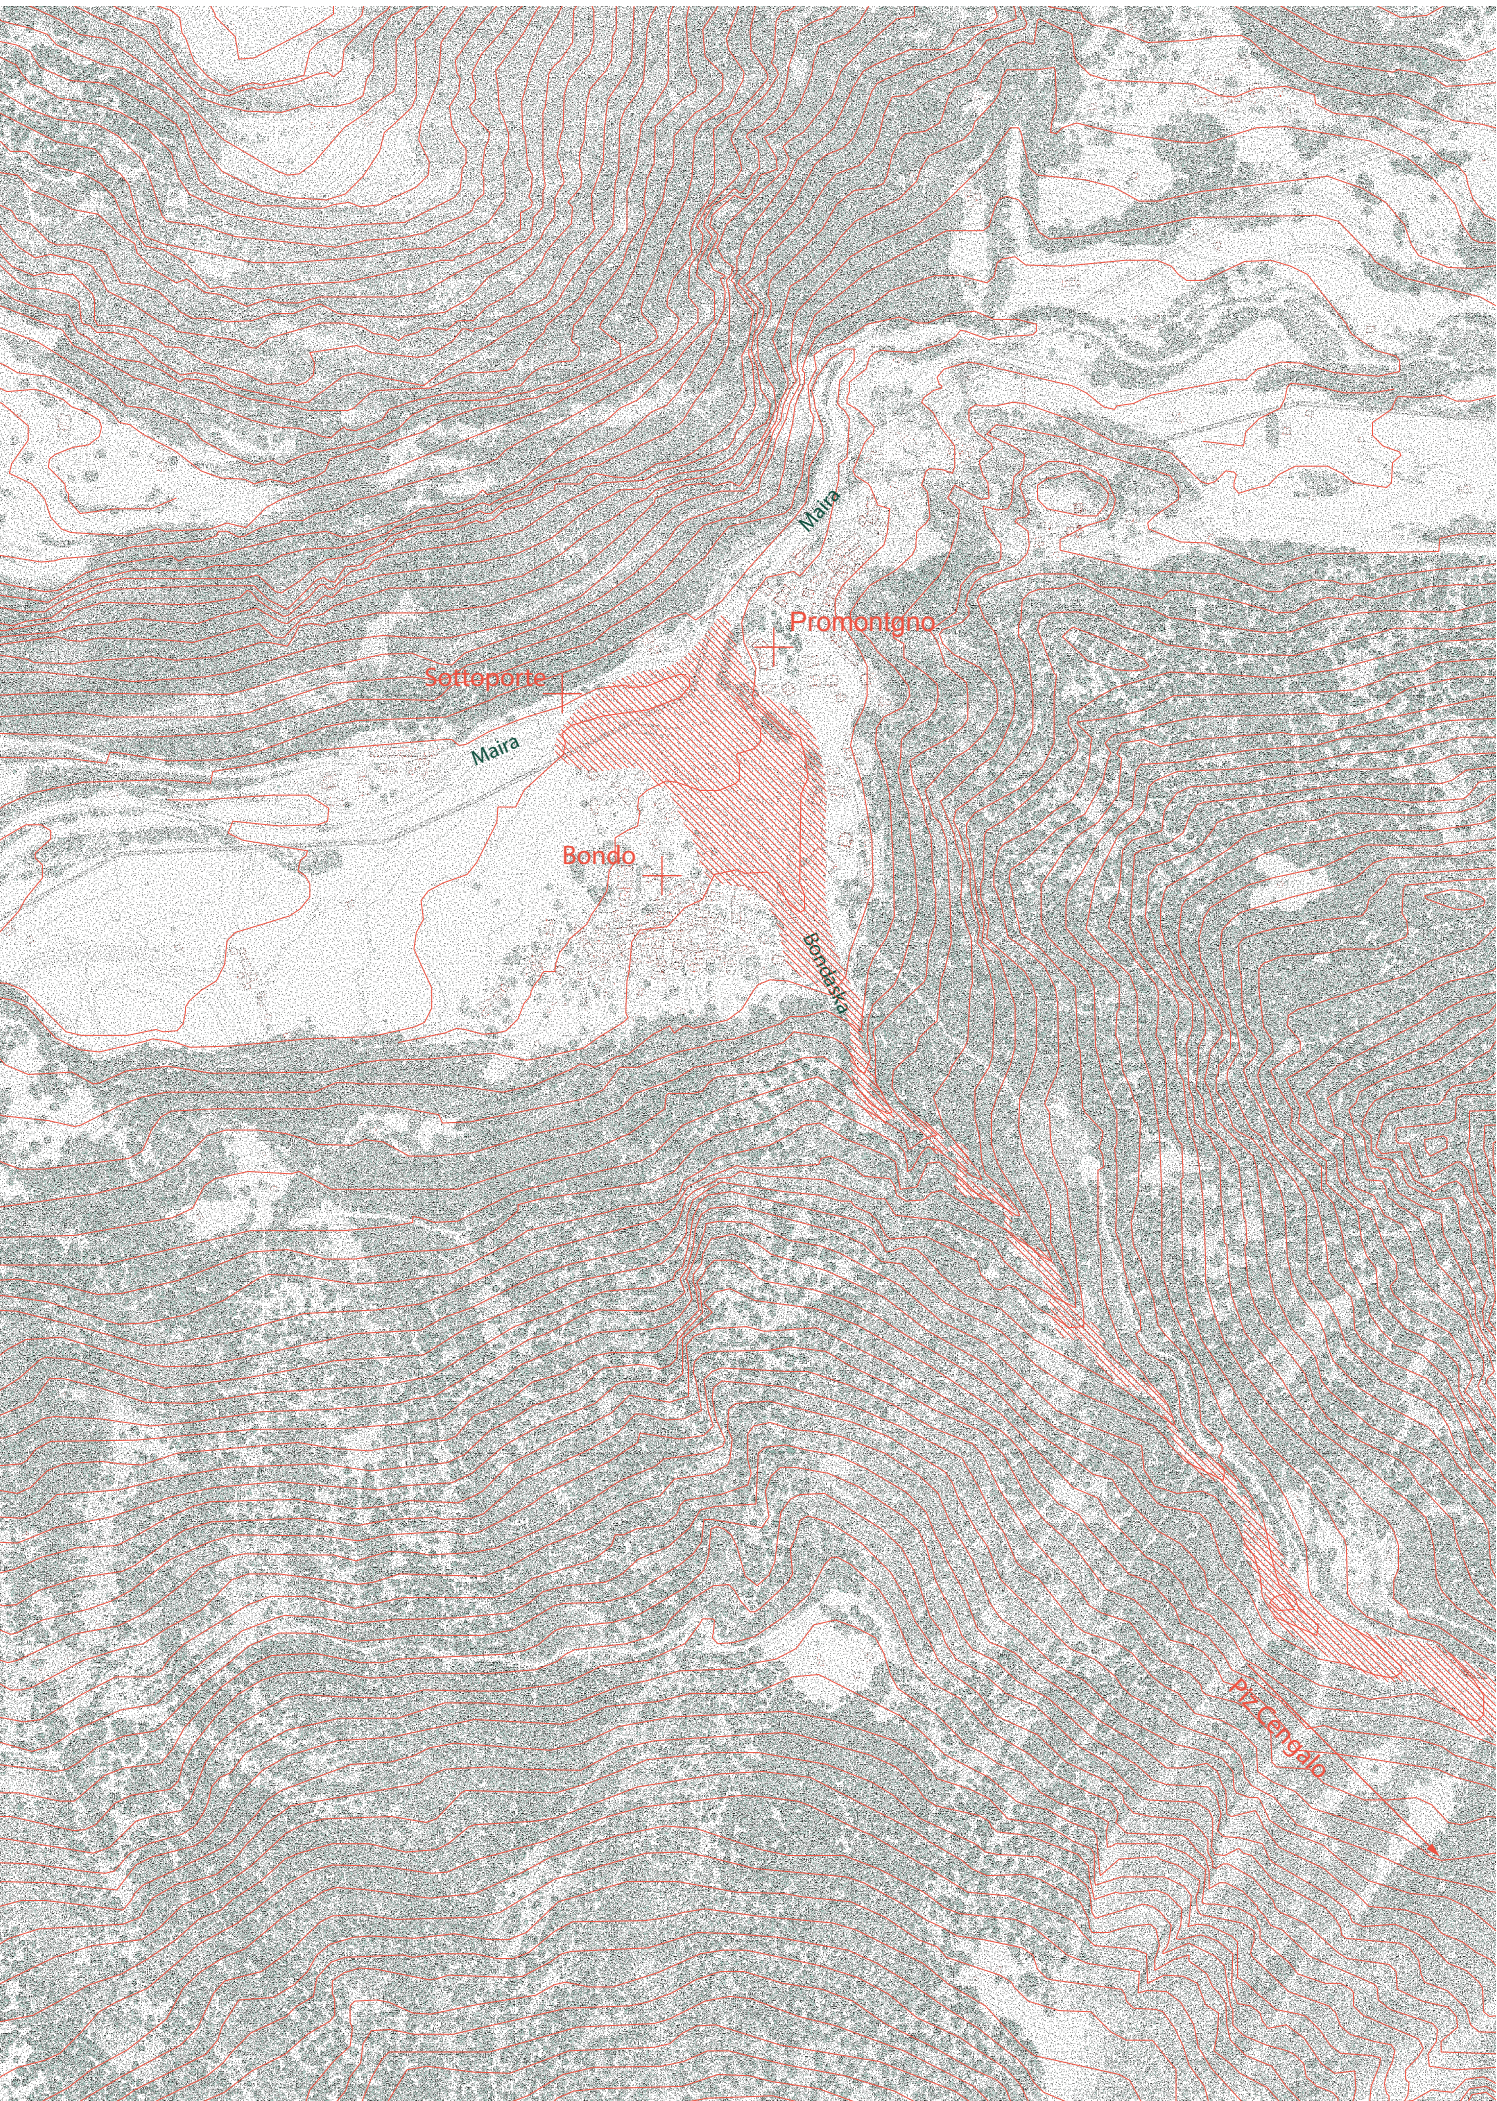
Impact area. 1: 10 000

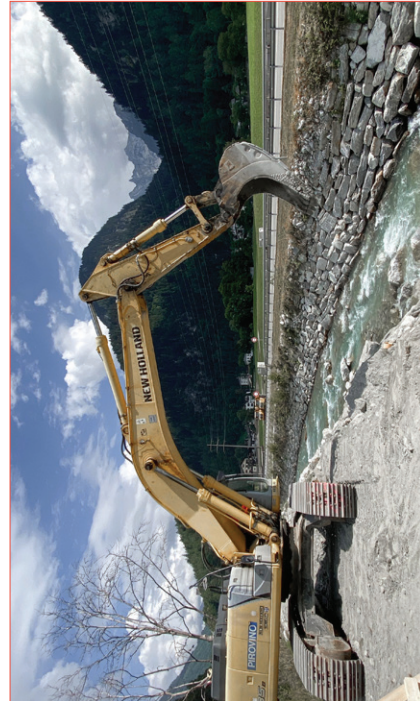
Removing debris from the river Maira.

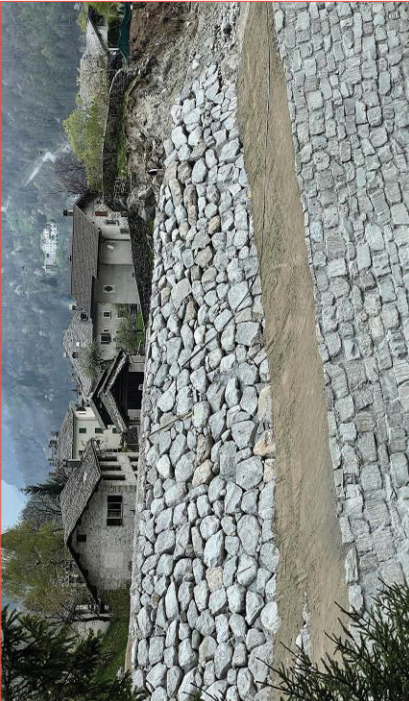
The upper half of the protective dams is built from the stone of the Piz Cengalo. (Photo: Hanspeter Schless)

The project adhered to strict regulatory standards due to the region’s vulnerability to natural hazards like landslides from Piz Cengalo. This required innovative engineering solutions to ensure structural integrity while harmonizing with the environment. Initially preferring local Soglio quartzite, logistical challenges led them to repurpose Bondasca granite dislodged by previous events, turning potential waste into a resource.

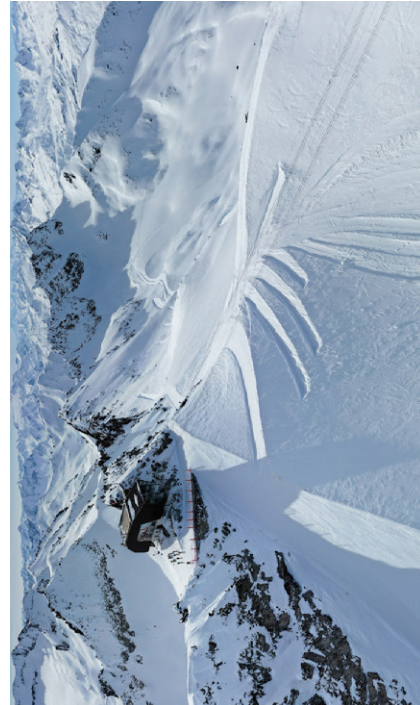
The melting of ice near the Gemsstock Hutte (Picture: Google Maps)

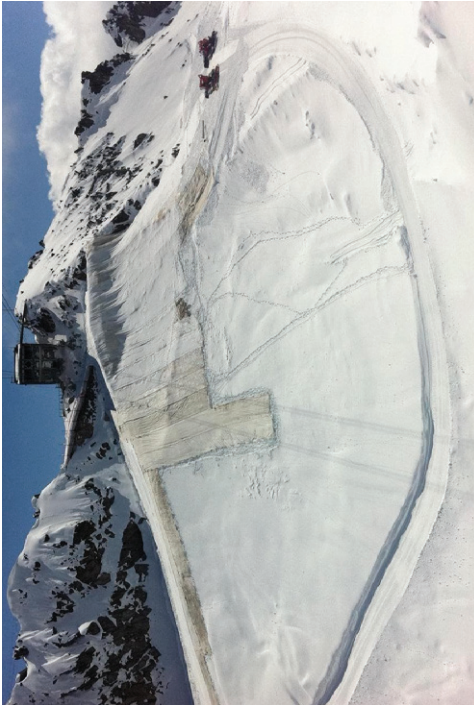
Unrolling thermal glacier blanket. (Picture: PD)

Imagine trying to spread and secure massive tarps over vast, remote ice fields. It requires meticulous planning, sturdy anchoring systems to withstand fierce winds and heavy snowfall, and ongoing maintenance to ensure they stay effective.

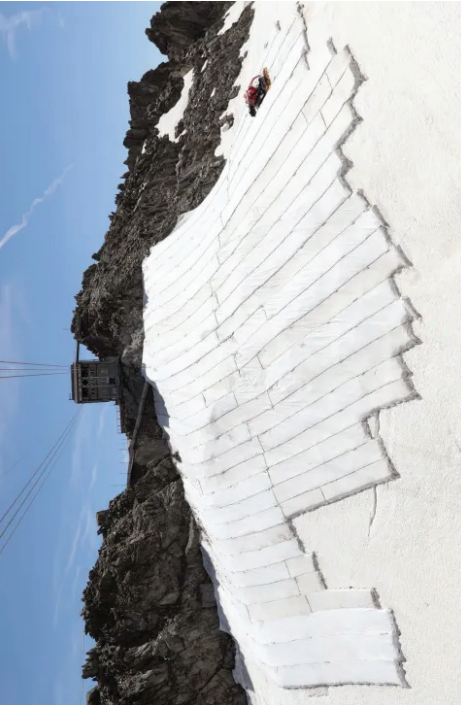
Parts of the Gurschengletscher glacier covered (Picture: Reuters)

In response to the urgent threat of global warming on glaciers, the Gurschen Glacier in Switzerland became a pioneering site for an innovative approach. Beginning in [year], large-scale tarps were strategically placed over the glacier during summer months. This ambitious effort aimed to mitigate melting by reducing the glacier’s exposure to direct sunlight and heat absorption.
